# DESIGN GUIDELINES

The Crowsnest Pass  
Historic District

# **THE CROWSNEST PASS HISTORIC DISTRICT GUIDELINES**

**Produced by The Alberta Main Street Programme  
a programme of  
The Alberta Historical Resources Foundation  
with the assistance of  
Alberta Culture and Multiculturalism  
and  
The Heritage Canada Foundation**

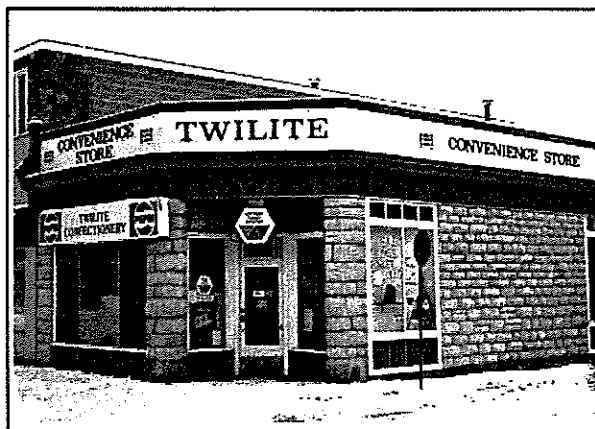
Fig. 143  
Blairmore, 1990  
Twilite Confectionary  
Replacement of the cornice and cleaning  
paint from the limestone returned this  
building to its earlier appearance.

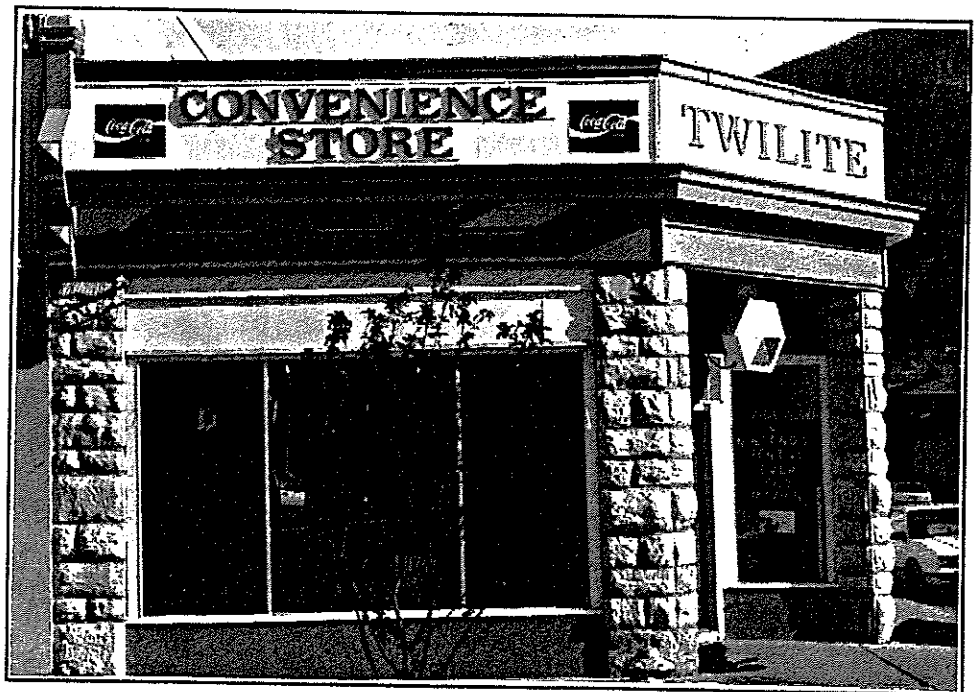
Fig. 151  
Blairmore, 1990  
The Twilite Confectionery, with cornice  
replaced.

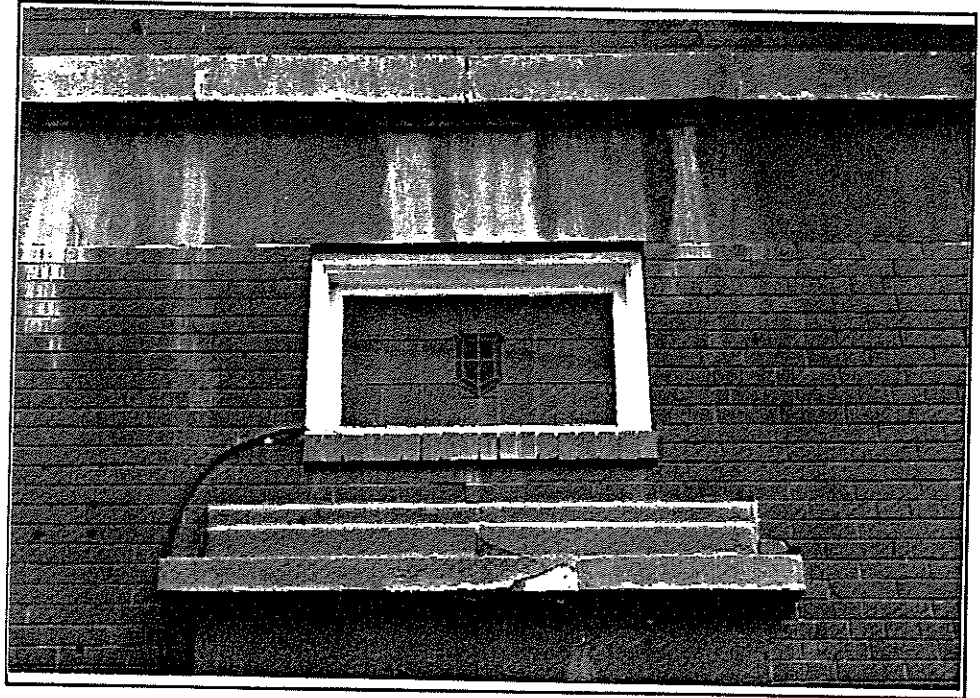
*Fig. 161  
Coleman, 1990  
Grand Union Hotel, (1924)  
Cast stone lintel and cornice.*

Cast stone is susceptible to weathering and staining and, like the other masonry materials in this section, requires professional advice prior to cleaning and repair (see Technical Resources).
